## **Monitoring of Streambank Stabilization and River Restoration Structures on Ice-Affected Rivers in Northern Vermont**

Andrew M. Tuthill

July 2009

Final report

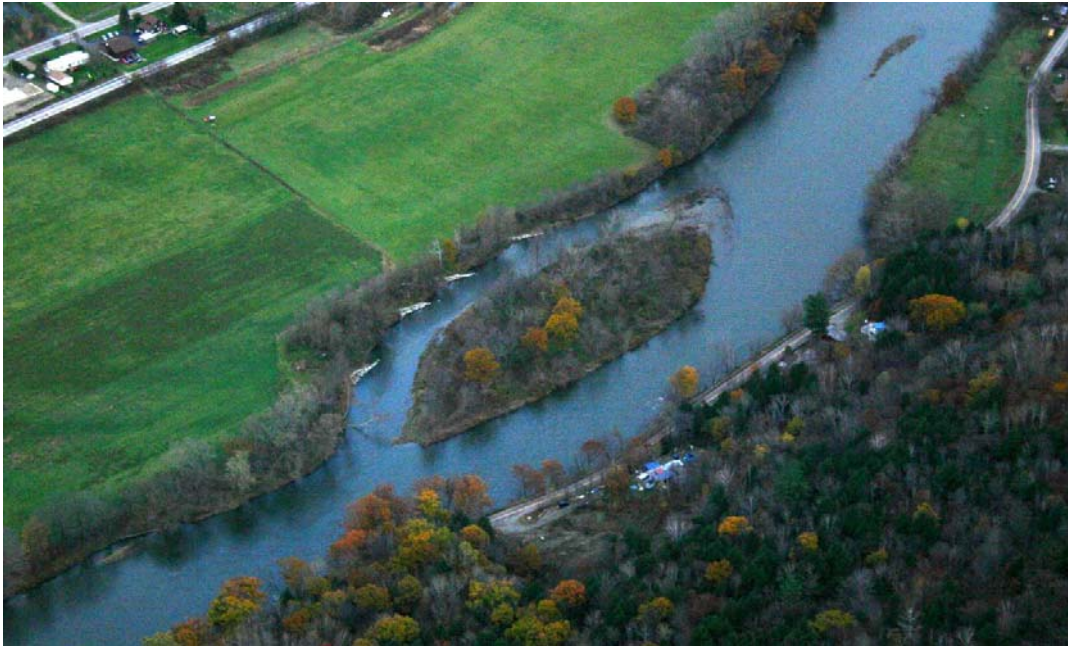
Four rock vanes help to stabilize about 800 ft. of bank along fields of the Fuller Farm in Bolton, VT (Figure 13). Designed by the NRCS, these vanes form about a 25° angle with the upstream bank. They have a mild upstream and a steep downstream slope to allow the ice to slide up and over, minimizing the potential for rock displacement (Figure 14). The vanes, which cost about \$8,000 each to build, are keyed 15 ft. into the top of the bank. They incline downward into the river to intersect the bed elevation about one-third of the way across the channel. About 2,000 live willow stakes, which were planted, appear to be thriving. Sediment has deposited along the shoreline upstream of the vanes while deep scour holes have formed in the channel downstream of the structures. The rocks, which are up to 4 ft. in diameter, were individually placed by a large excavator. The ramp-like form of the vanes provided convenient access for

Figure 13. Rock vanes on the Winooski River, Fuller Farm, Bolton, VT on 11/2/05.

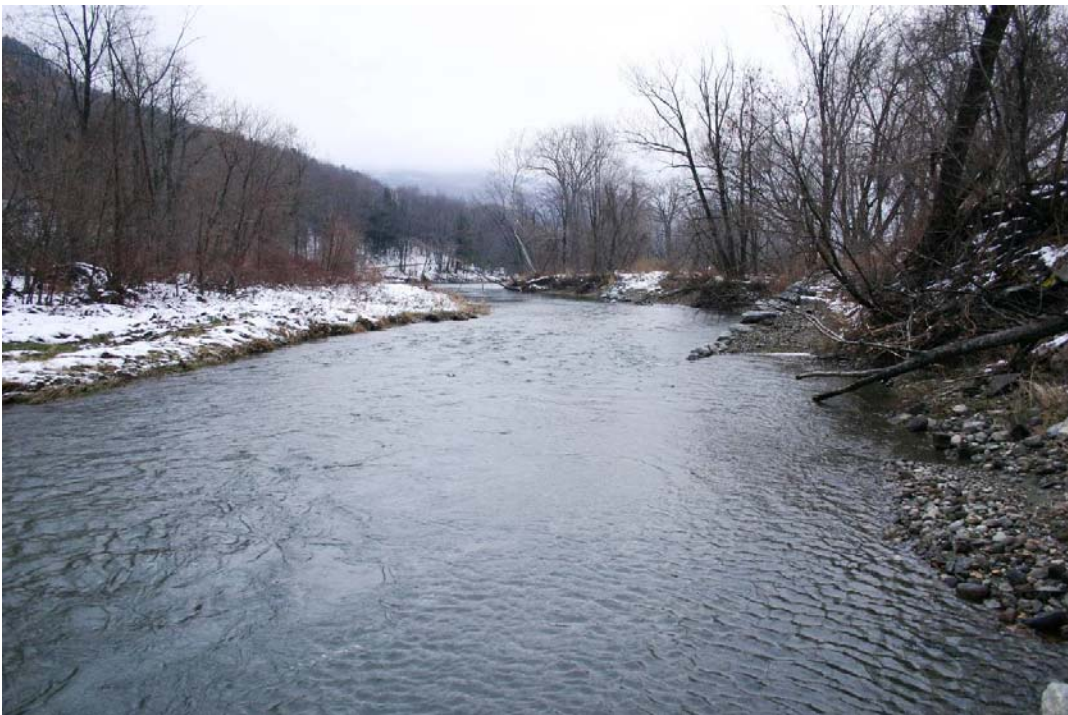
Figure 14. Rock vanes on the Winooski River, Fuller Farm, Bolton, VT viewed from upstream on 11/2/05.

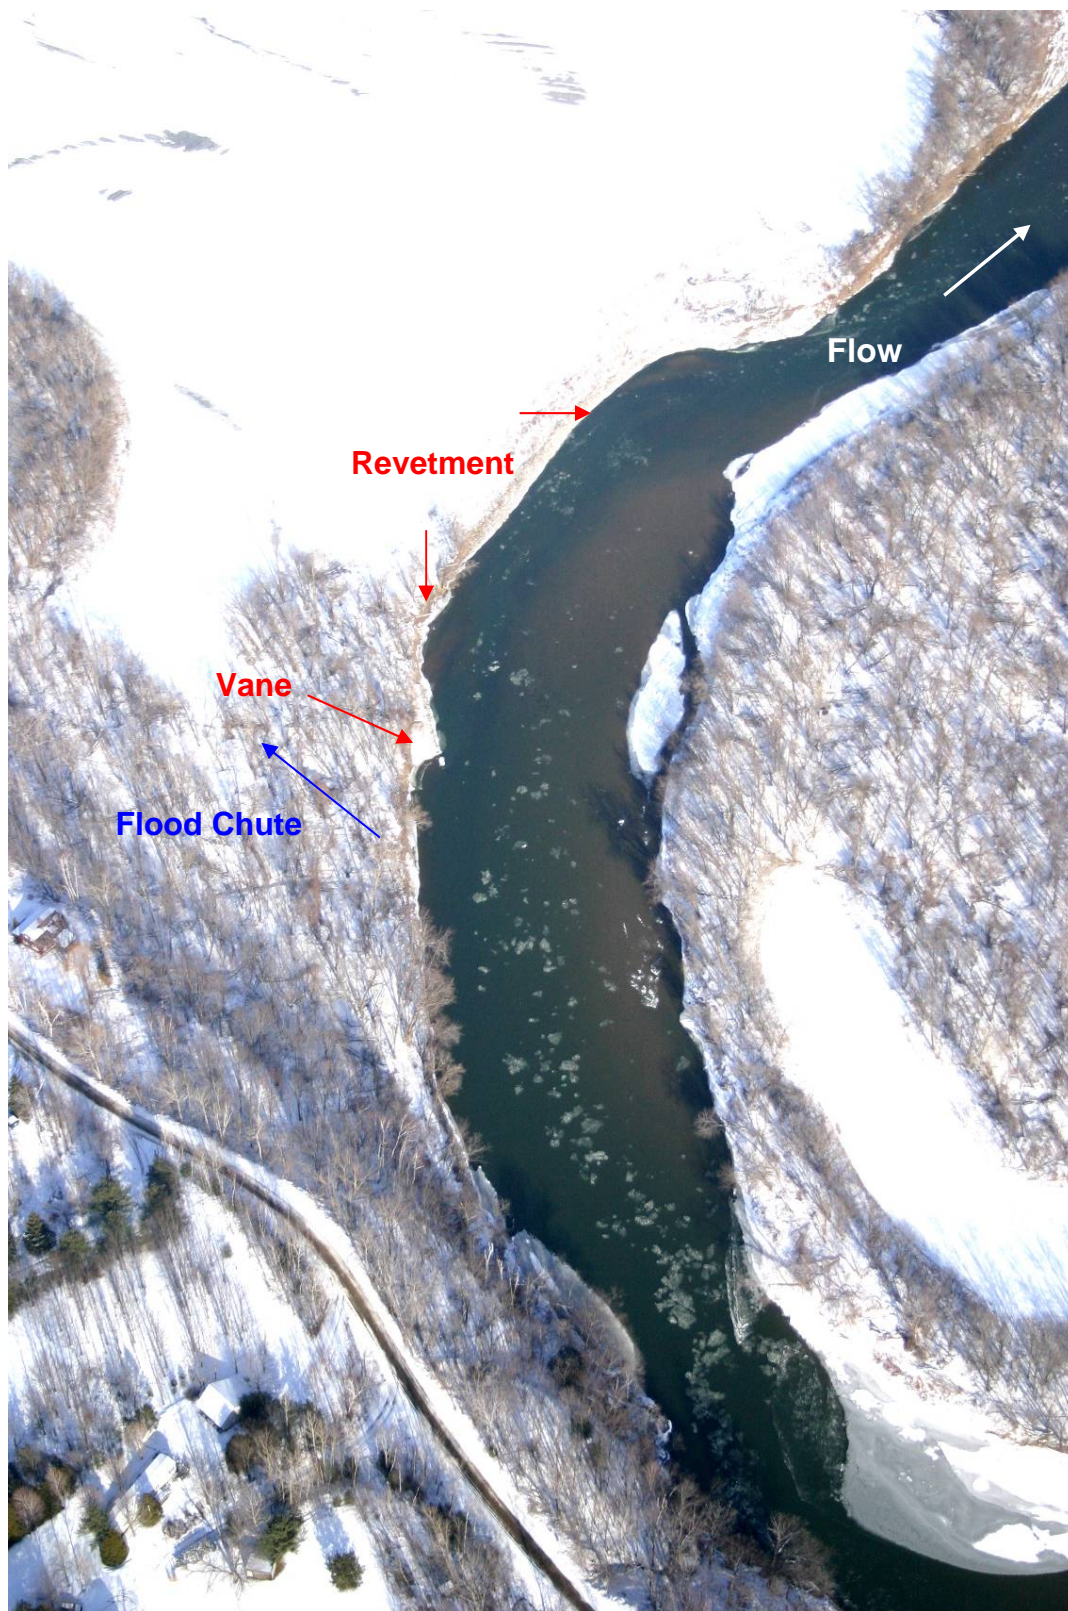
A large rock vane and stone revetment stabilize the banks at the Snowflake Farm property, about 1 mile downstream of Richmond Village (Figure 16). This NRCS vane, shown in Figures 17 and 18, is similar to but larger than the Bolton Farm vanes. Constructed of 4'×3'×2' quarried stone, the 30-ft-long structure is keyed 20 ft. into the top of the wooded bank and ramps gradually into the river forming a 15° angle with the upstream bank. The structure is built at the entrance to a flood chute where, during high flow events, water escapes the main channel to shortcut the wide bend downstream. Downstream of the vane, the edge of a field has been

Figure 16. Frazil pans drifting past vane and revetment at the Snowflake Farm property downstream of Richmond, VT, 1/31/08.

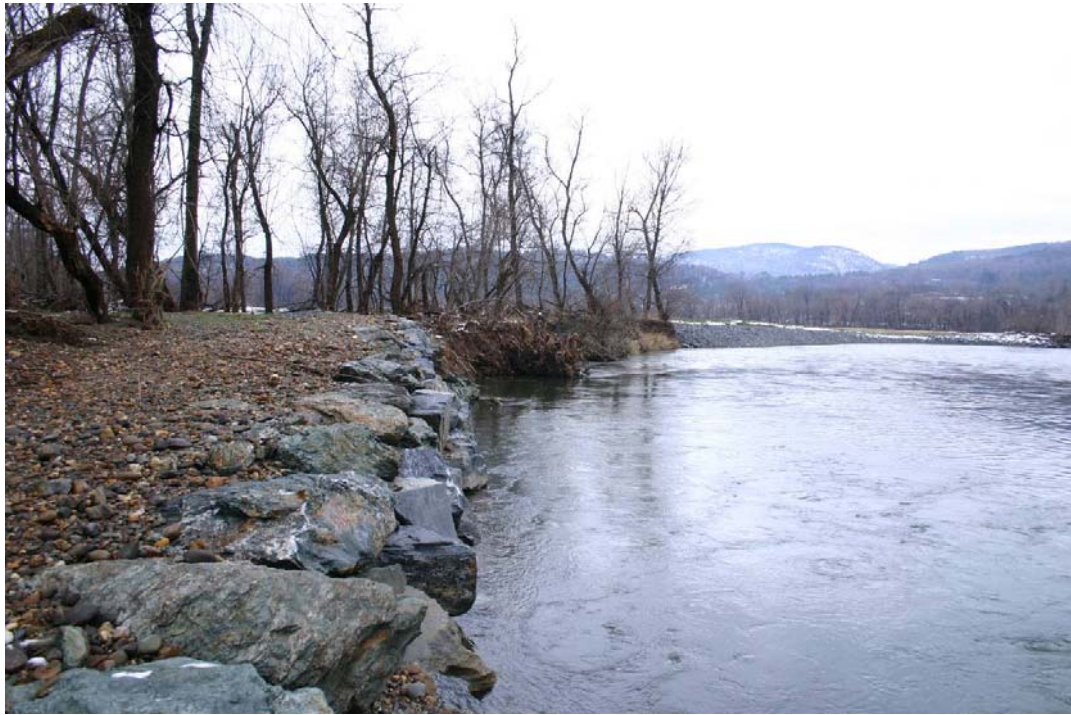
armored with about 800 ft. of riprap, reinforced with buried root wads spaced about 50-ft-apart. It appears that the vane serves in part as a flow deflector to protect the upstream end of the revetment. The total cost of this NRCS project was \$60,000, \$15,000 of which was for the vane.

Figure 17. Vane and revetment at Snowflake Farm viewed from upstream on 11/28/05.

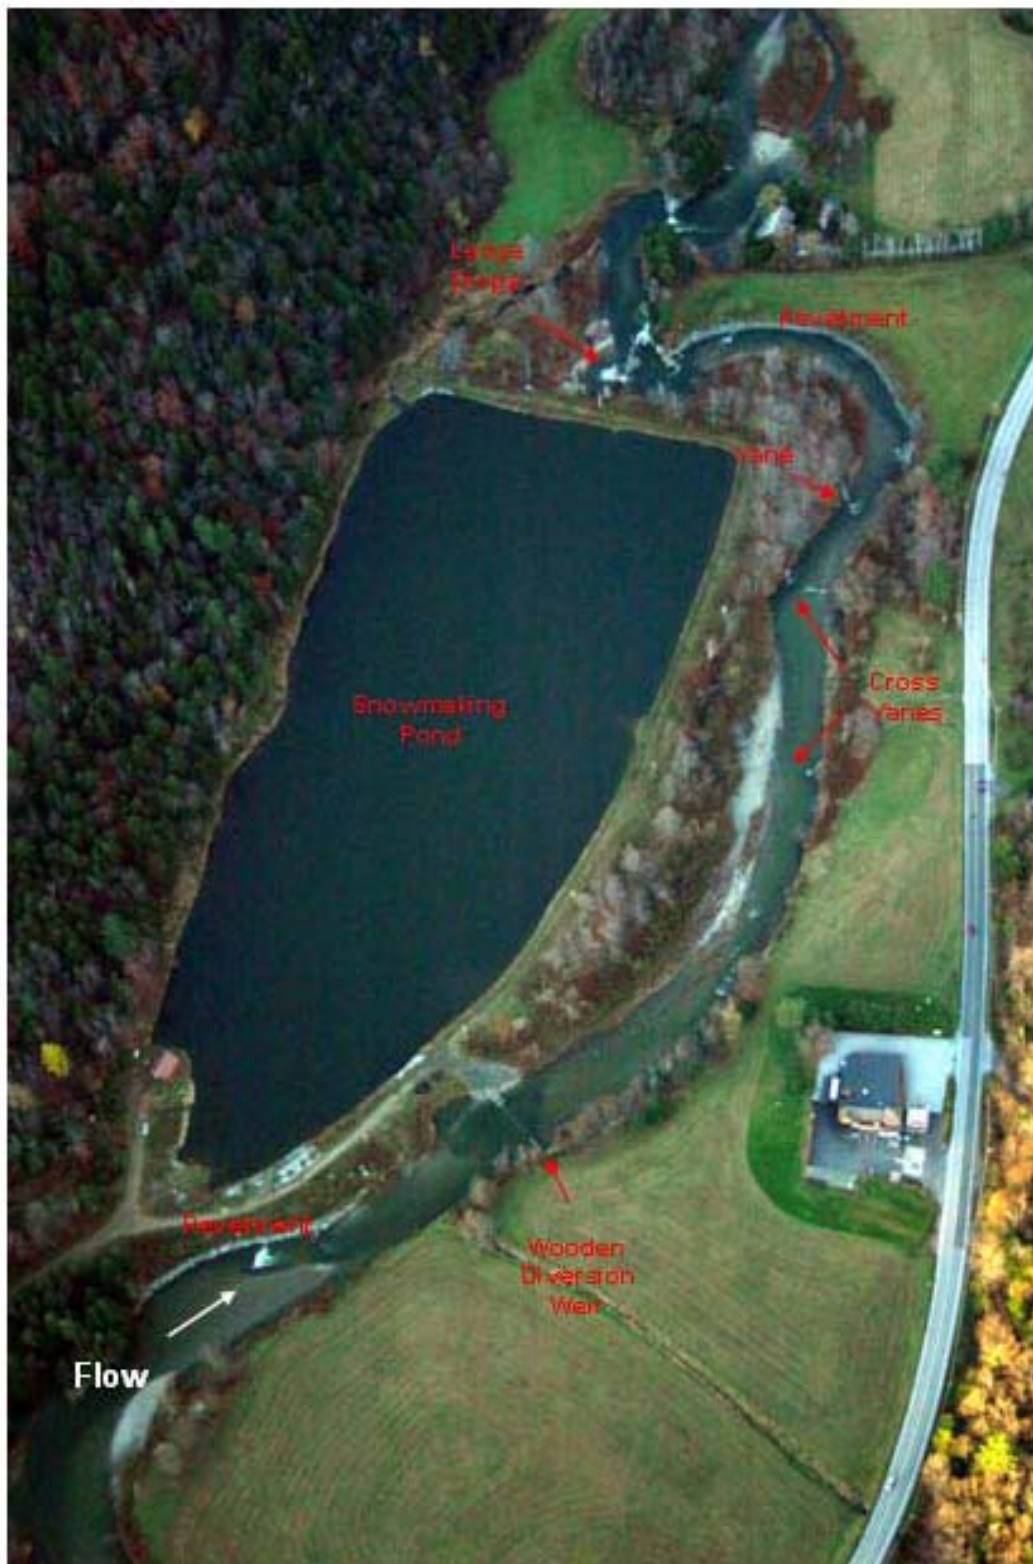
This project on the Mad River, two miles below Warren, includes two cross vanes, a vane and two revetments that stabilize banks and improve conveyance around a man-made snowmaking water storage pond (Figures 22-24). At the head of the reach, a stone revetment armors the bank along the pond. Below the revetment, a gated wooden weir serves the dual purposes of grade control and pond filling. Downstream, two cross vanes and a single vane encourage sediment deposition along the left side of the channel and concentrate flow towards the channel center.

Figure 22. Channel restoration structures on the upper Mad River at the Warren snowmaking ponds. 11/2/05

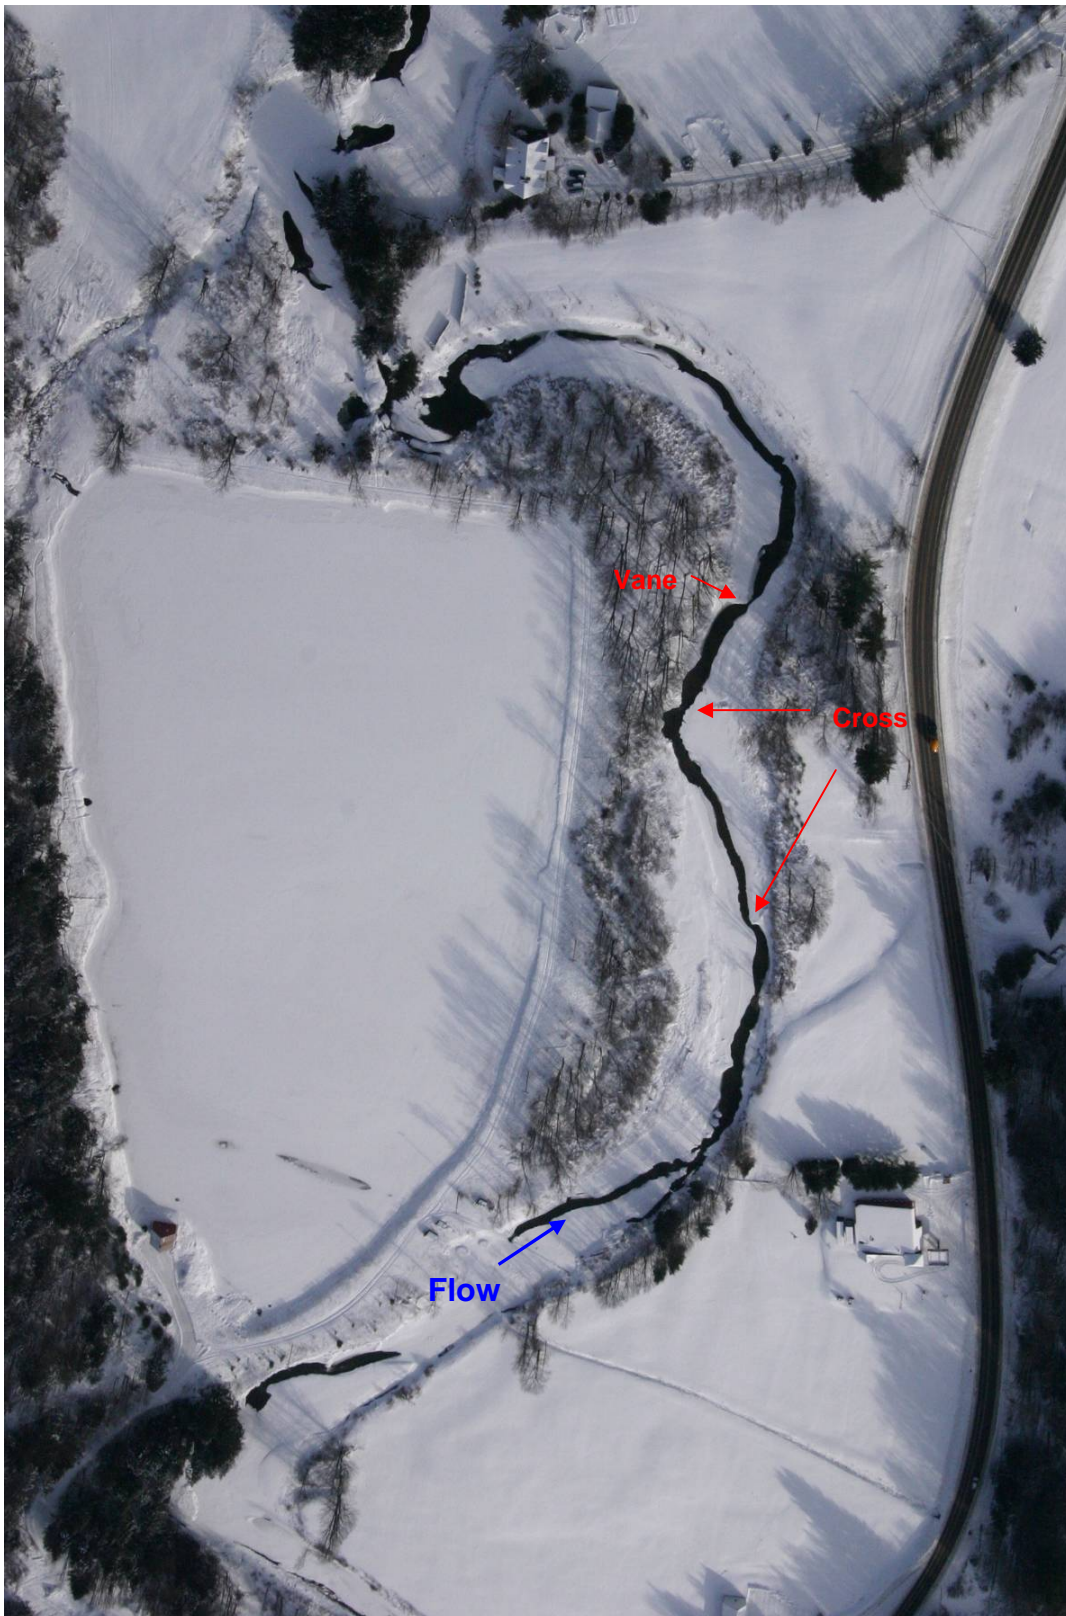
Figure 23. Partial ice cover on the upper Mad River at the Warren snowmaking ponds.  
12/21/05.

An aerial view on 10 January 2006 shows a continuous open lead along the path of fastest current. The lead narrows at the structures where border ice has formed around the vanes (Figure 23). It appears that the river is still aggrading in the vicinity of the upstream cross vane, as the rocks forming the left hand vane (facing downstream) are now nearly buried in gravel (Figure 24).

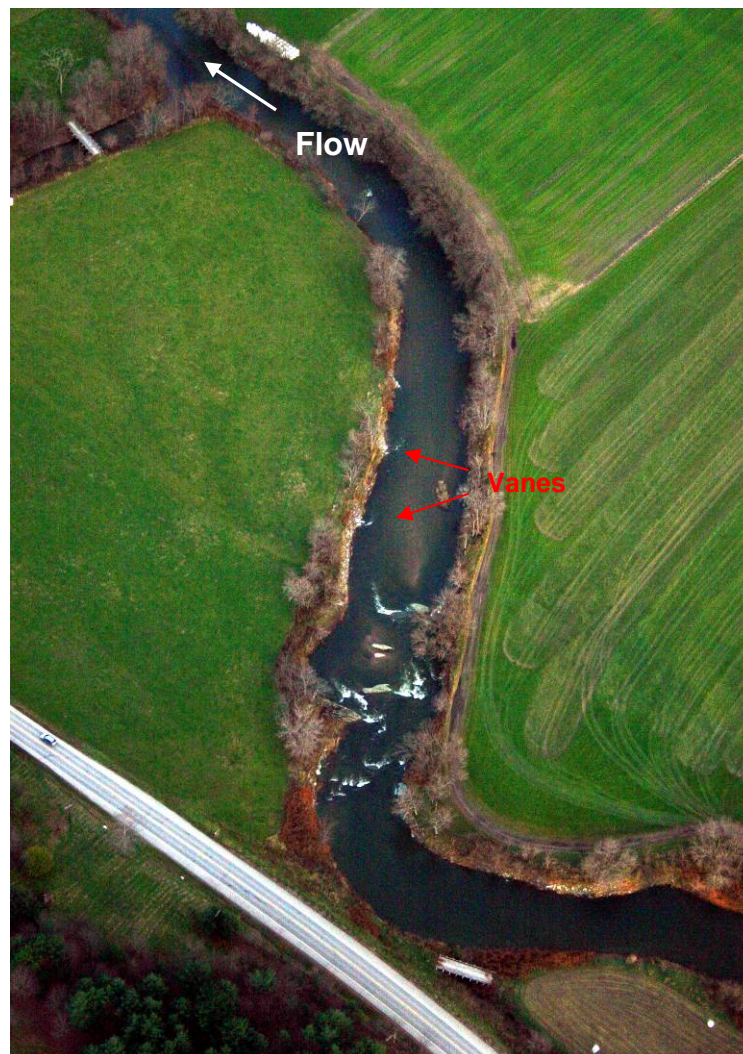
Three rock vanes or spur dikes were built along the left bank of the Mad River upstream of the Turner Farm near a location where, on past occasions including a 1998 flood, the river has gone out of bank to erode a large portion of an adjacent field (Figure 27). The designer's intention may have been to stabilize the bank in response to the 1998 flood, but because the vanes do not extend far enough out into the channel, or because they have been extensively damaged by ice or erosion, they did not appear to have much effect on flow patterns during an 2 November 2005 visit to the site (Figure 14). Tree scars in the vicinity of the project suggest that dynamic ice breakups occur at this site. It is unknown whether any of the overbank flow events and field erosion was ice jam related.

Figure 27. Mad River. Turner Farm vanes 11/2/05

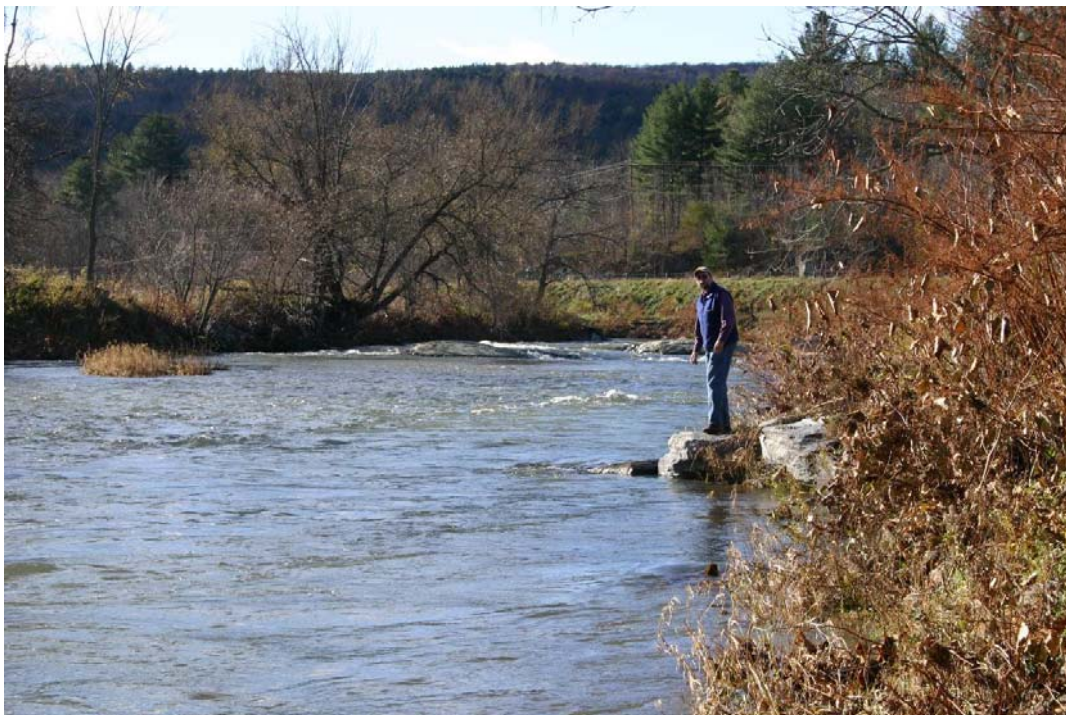
Figure 28. Mad River. Turner Farm upstream vane 11/2/05.

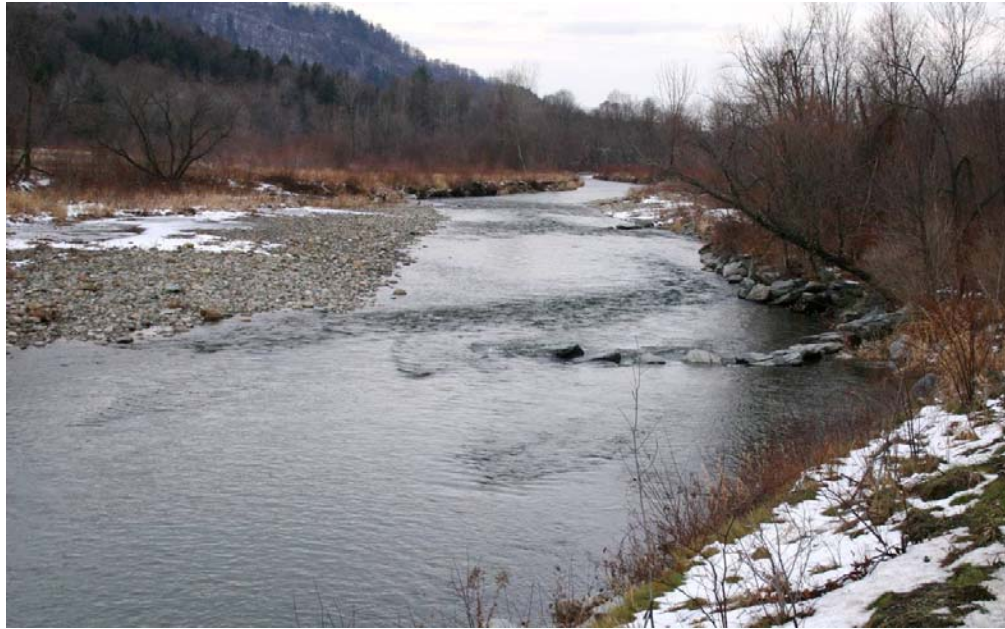
The project performed successfully for its first five years until an extreme flow event, on 17 October 2005, deposited a large volume of coarse bed material in the meander, causing a major avulsion into the blocked-off former channels to the right (Figures 30-34).

Figure 30. Cross vanes stabilize banks of channel diverging from Rt. 118 on the Trout River  
11/28/05

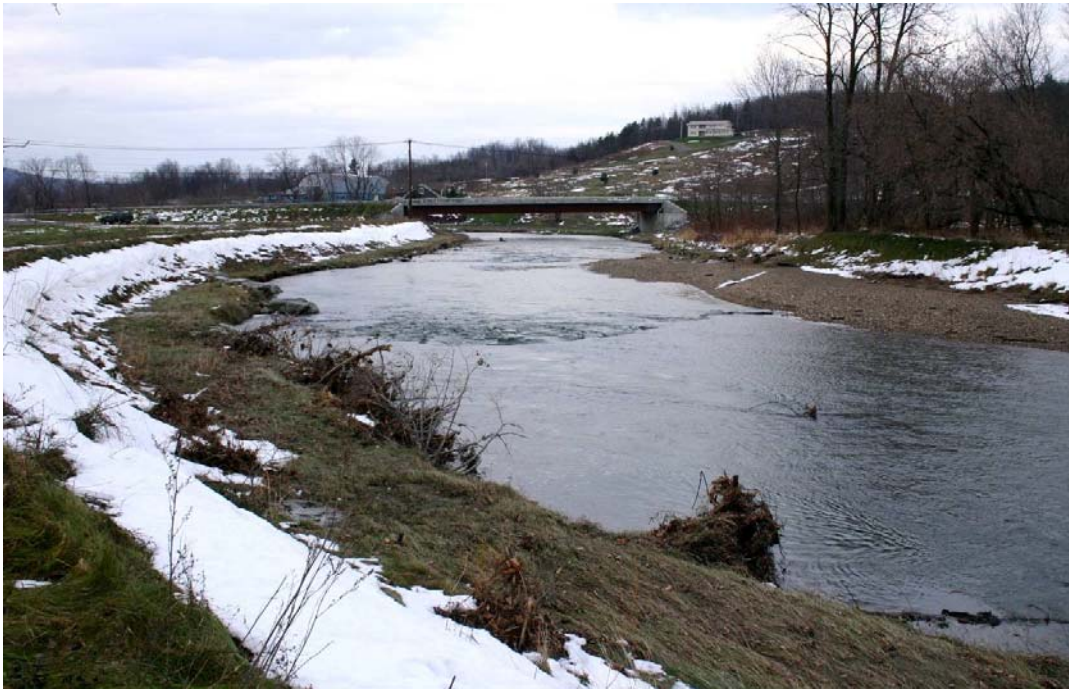
This river restoration project, completed in 2004, consists of a series of vanes, cross vanes, U-drops and rock riffles to control grade and direct the lower Trout River through a new bridge opening on VT Route 118 (Figures 36 and 37). Design and construction were overseen by the Vermont Department of Transportation (V-Trans). Root wads protrude from reshaped banks near the rock structures, and tree revetments were also installed at a few locations. Two rock riffles are located 300 and 1000ft. upstream of the bridge, consisting of four rows of large rocks. These help control grade, along with a series of U-drops and rock weirs. To the right of the restored channel, several channel blocks cut off a former flood chute.

Figure 36. Trout River looking downstream at a U-drop and rock riffles at the East Berkshire Bridge restoration project on 11/28/05.

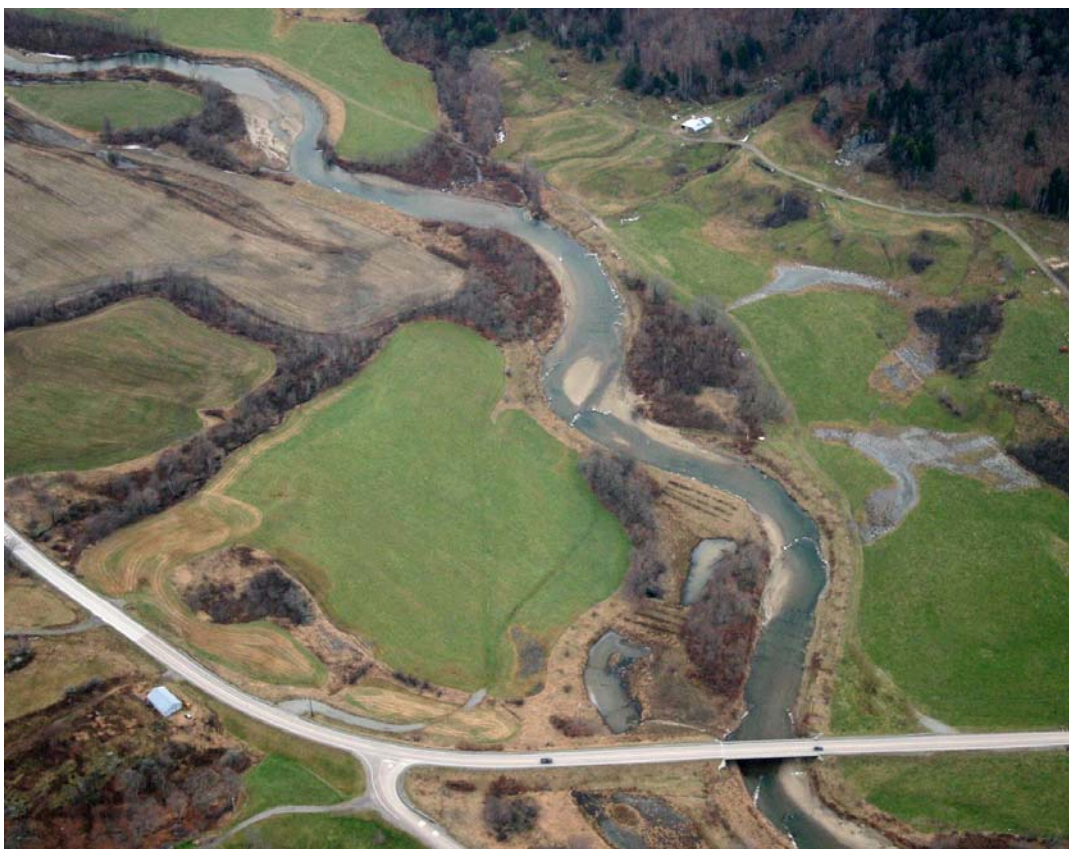
Figure 37. Trout River looking upstream at the East Berkshire Bridge restoration project on 12/3/08.

The structures were overtopped and the flood chute was accessed during the same high flow event that damaged the upstream Montgomery Center project in October 2005. However, no significant damage or deposition appears to have resulted. It may be that the East Berkshire Bridge project is better suited to withstand high flow events due to lower channel sinuosity and more equilibrium conditions in terms of bedload transport and deposition. Extensive grading and planting have been done on the left bank upstream of the bridge.

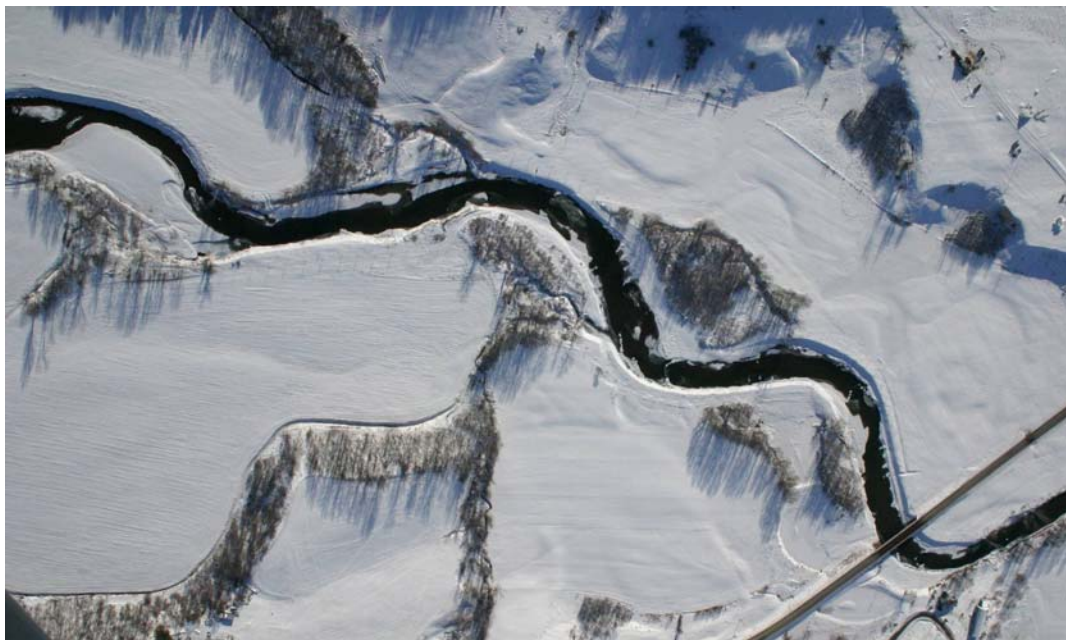
Other than enhancing the growth of border ice in the immediate vicinity of the structures, ice formation in the project reach appears to be very similar to ice growth in unaltered natural sections of the Trout River. Figure 38 shows ice starting to form on the limbs of the in-stream structures on January 4, 2006 and Figure 39 shows a more complete ice cover on the project reach on January 31, 2008.

Figure 38. Trout River looking at the East Berkshire Bridge restoration project on 1/4/06.
